Pavement Management & Asset Preservation 101

HOLBROOK
ASPHALT CO.

Pavement Preservation

High Density Mineral Bond (HA5)

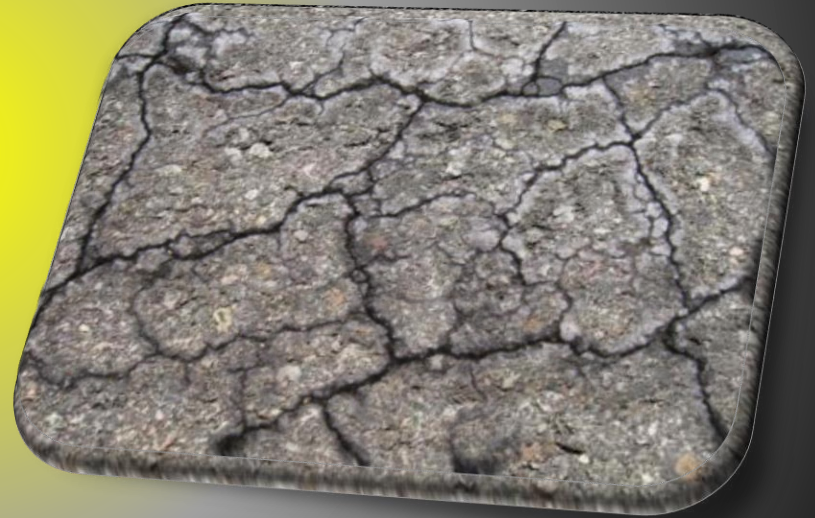
- The key to extending pavement life is to preserve the asphalt binder.
STOP OXIDATION!
 - Oxidation causes:
 - Raveling (loss of bond between aggregate and binder)
 - Cracking

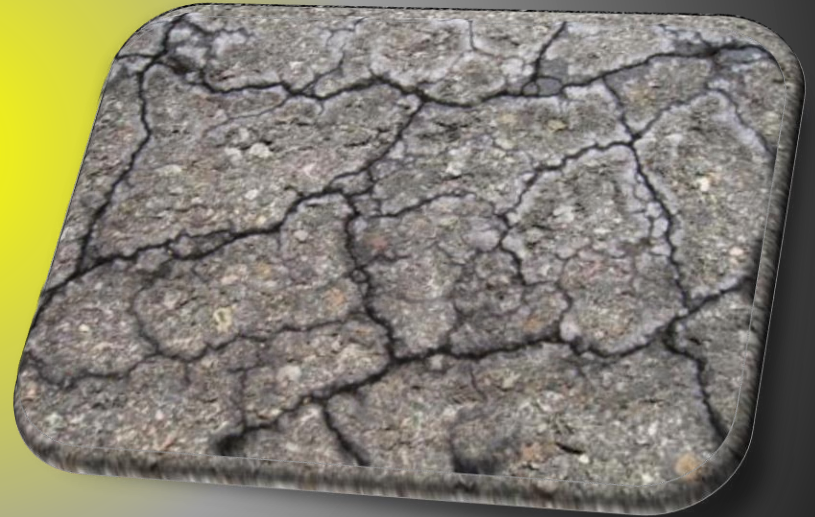
- Primary causes of OXIDATION:

- UV Rays

- Moisture

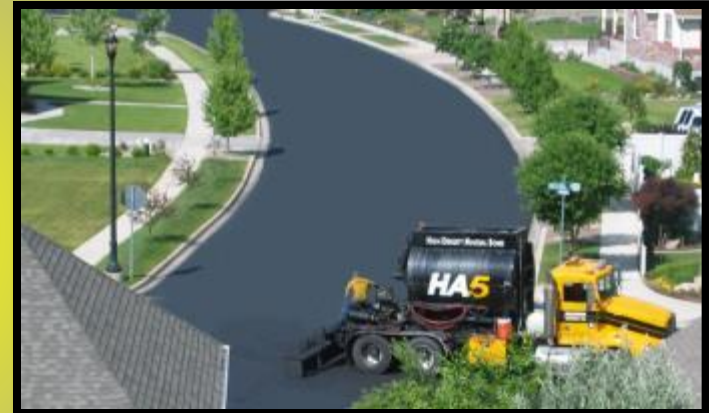
Summary: Specifically for local roads, HA5 is comprised of a mixture of a dense mixture of fine aggregates and polymers suspended in an asphalt emulsion. Reduces cracking and raveling by effectively preserving the existing asphalt binder. Effectively deflects UV rays. Depending on pavement condition, installations guaranteed for 5-years. Aesthetically pleasing “surface friendly” finish.

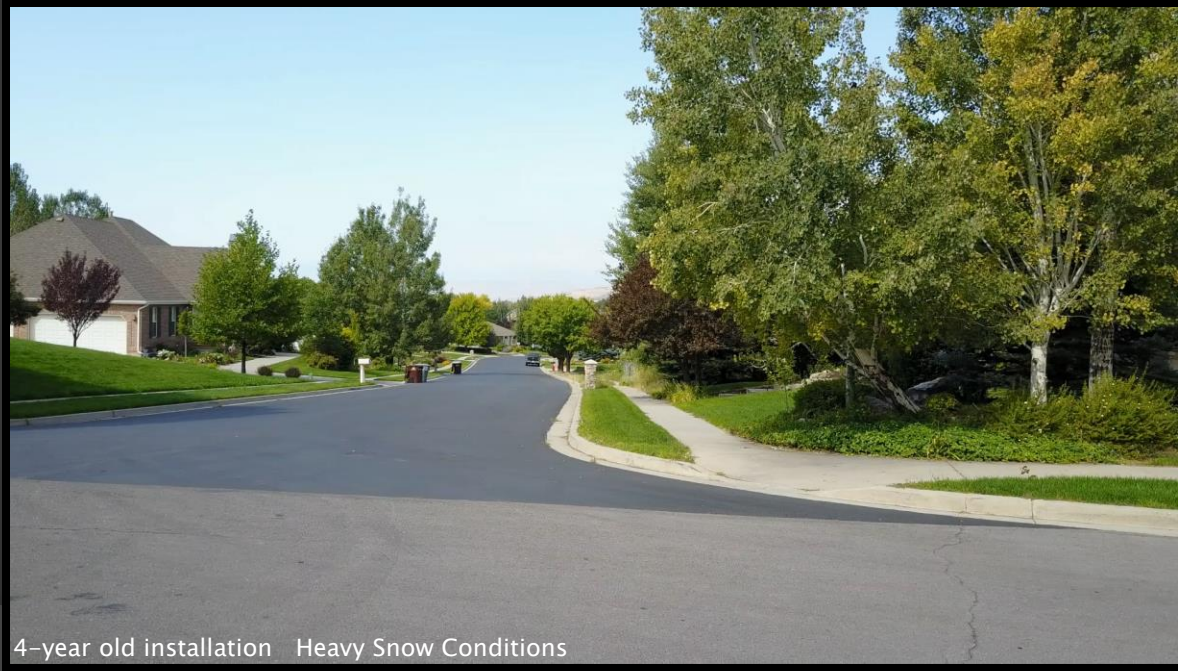
Alpine, UT

4-year old installation Heavy Snow Conditions

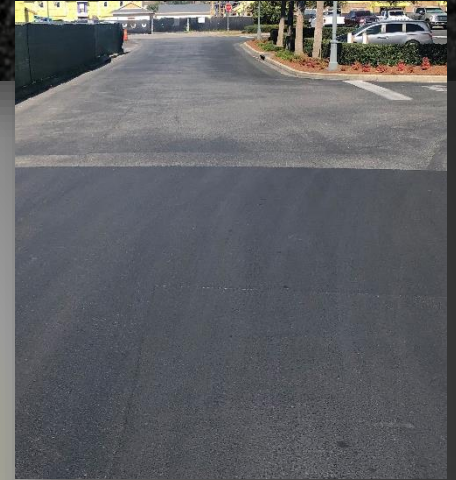
Premium seal coat
installation: Feb 2018

HA5 installation: Feb 2018

Age of Treatment Installation:
Picture taken Jan. 31, 2020
(2 YEARS)

Original paving of streets: 1999

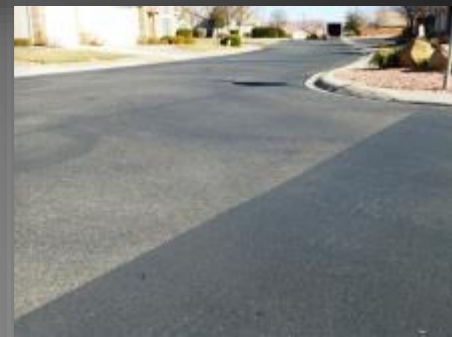
Premium seal coat installation:
May 2009

Painted Desert
Age of Treatment Installation:
2009 (4 YEARS - 2013)

HA5 installation: May 2009

Pavement Installation: 2003

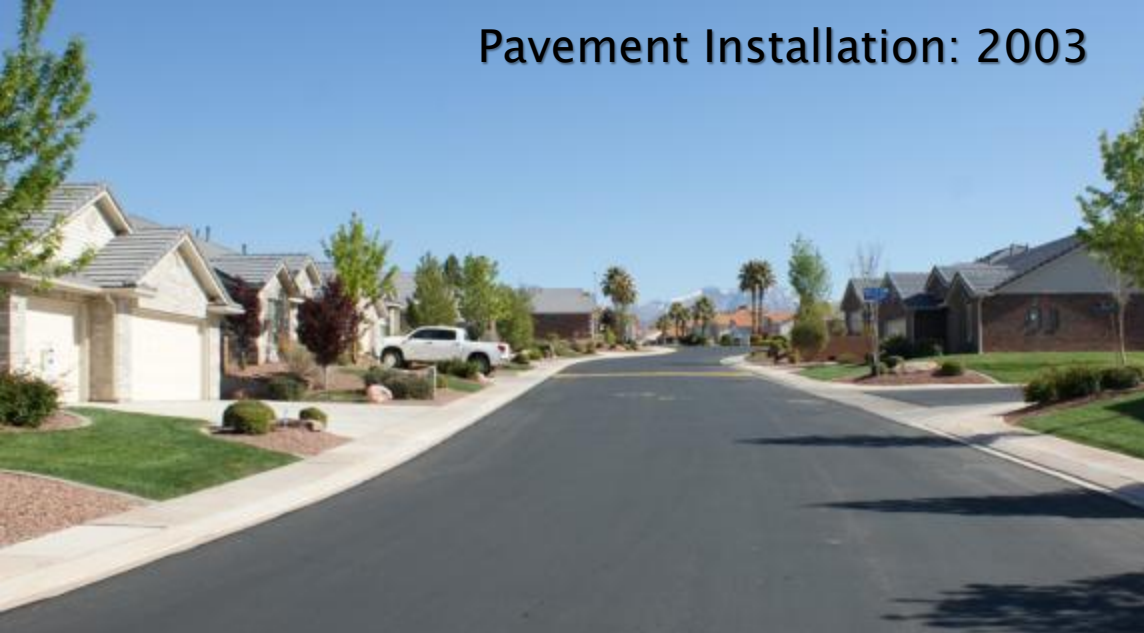
Coventry Lane
Age of Treatment Installation:
2006 (Year 2011 – 5 YEARS)

Actual Crack Ratio: **0.013**

Average Crack Ratios of Similar Age
Pavement: **0.040**
