RE: Report of Consulting Engineering Services
Dunlop Lane Geophysical Study
Clarksville, Montgomery County, Tennessee
TTL Project No. 26-08-00220

DUNLOP LANE - SEISMIC REFRACTION TESTING

MONTGOMERY COUNTY ENGINEERING

CLARKSVILLE, MONTGOMERY COUNTY, TENNESSEE

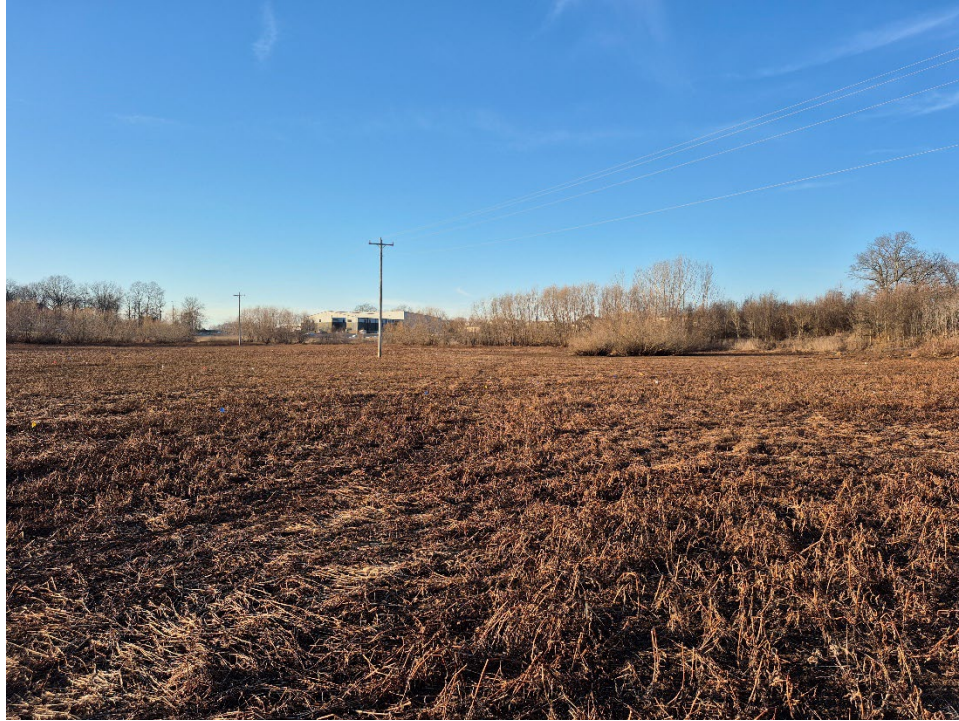
View looking northwest from near the southeast part of the study area

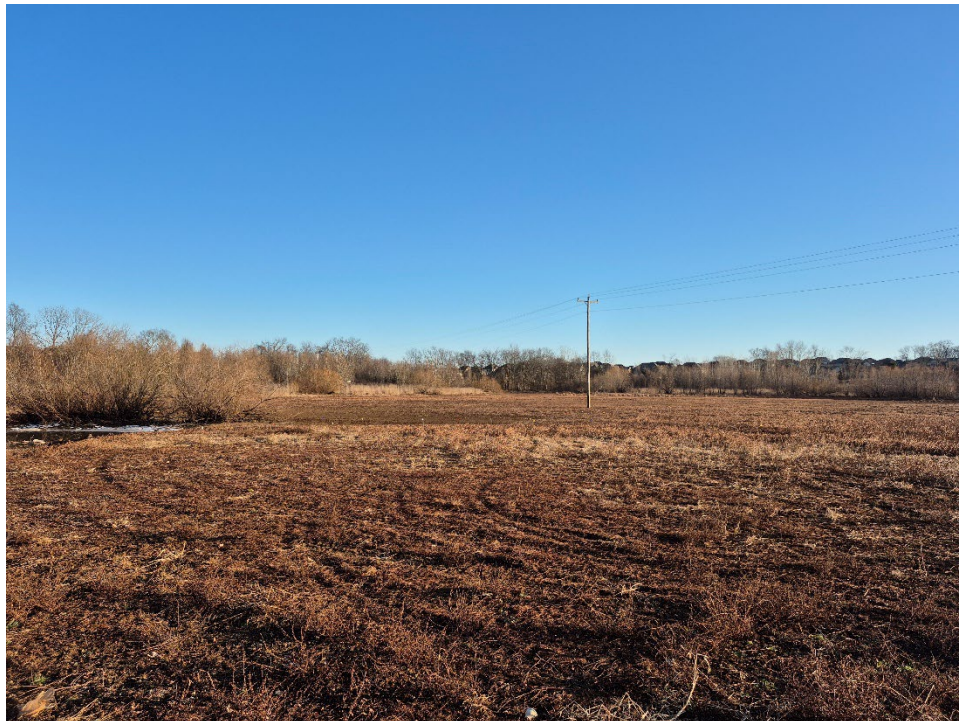
View looking south from near the northwest part of the study area

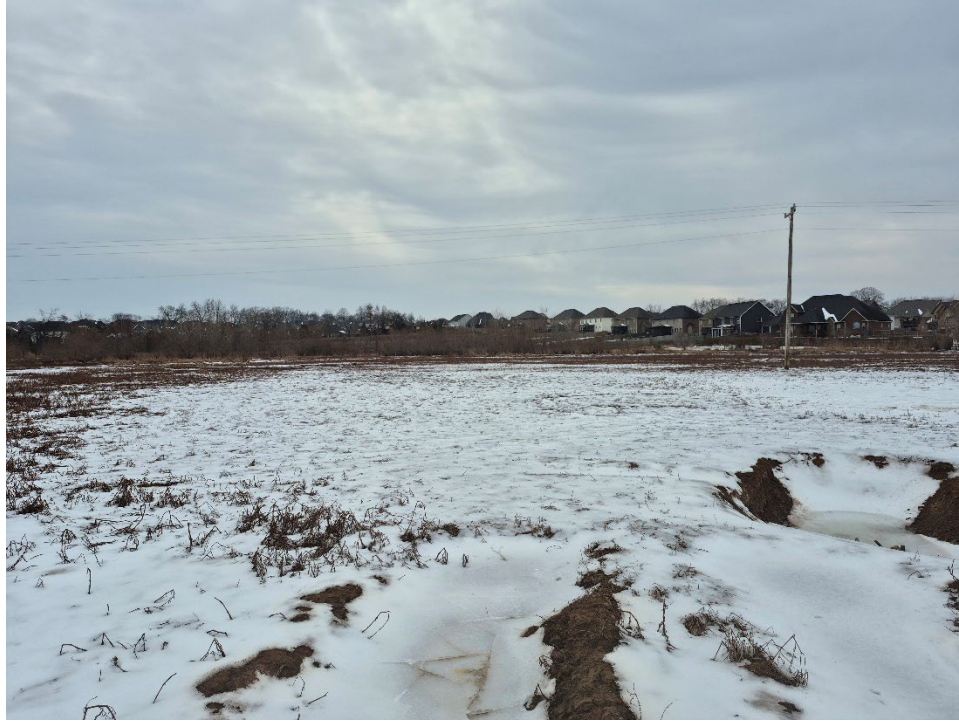
View looking west from east part of the study area. Depression SH-01 also visible on the right

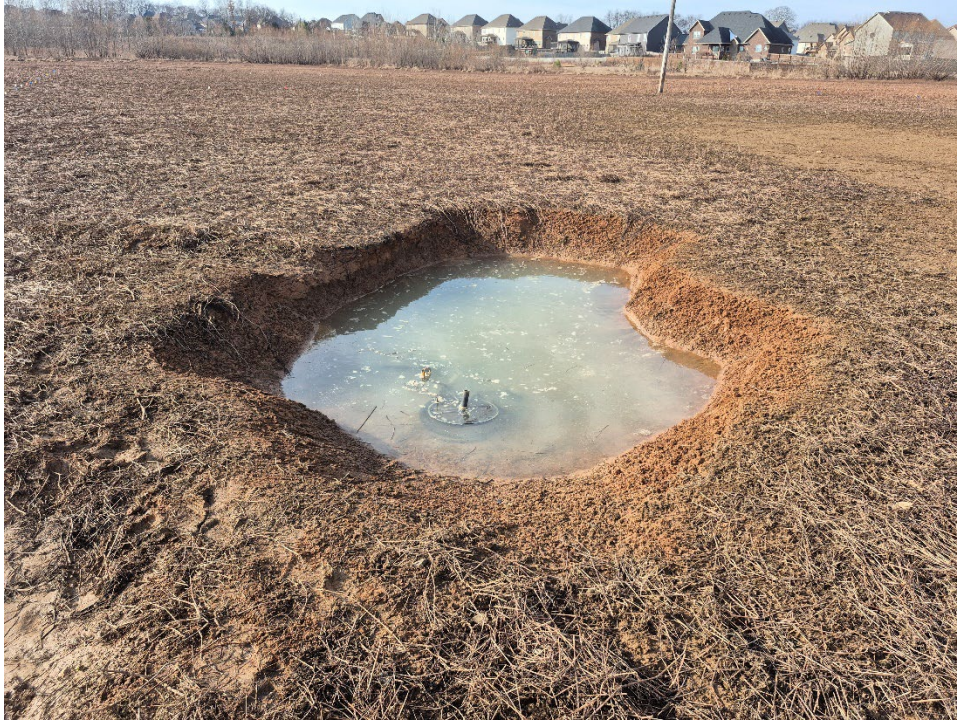
Feature ID	Approximate Coordinates ¹	Description
SH-01	36.5751 N, 87.2263 W	approximately 5 feet by 10 feet with no obvious open throat observed. The feature was approximately 3 feet deep and contained about 2 feet of water.
SH-02	36.5753 N, 87.2265 W	approximately 30 feet in diameter and 2-to 3-foot deep, containing about 6 inches of water at the time of observation. No open throat was visible.
SH-03	36.5753 N, 87.2268 W	approximately 4 feet in diameter about 2 feet deep, with no open throat observed. Water was not present.

View looking at depression SH-01

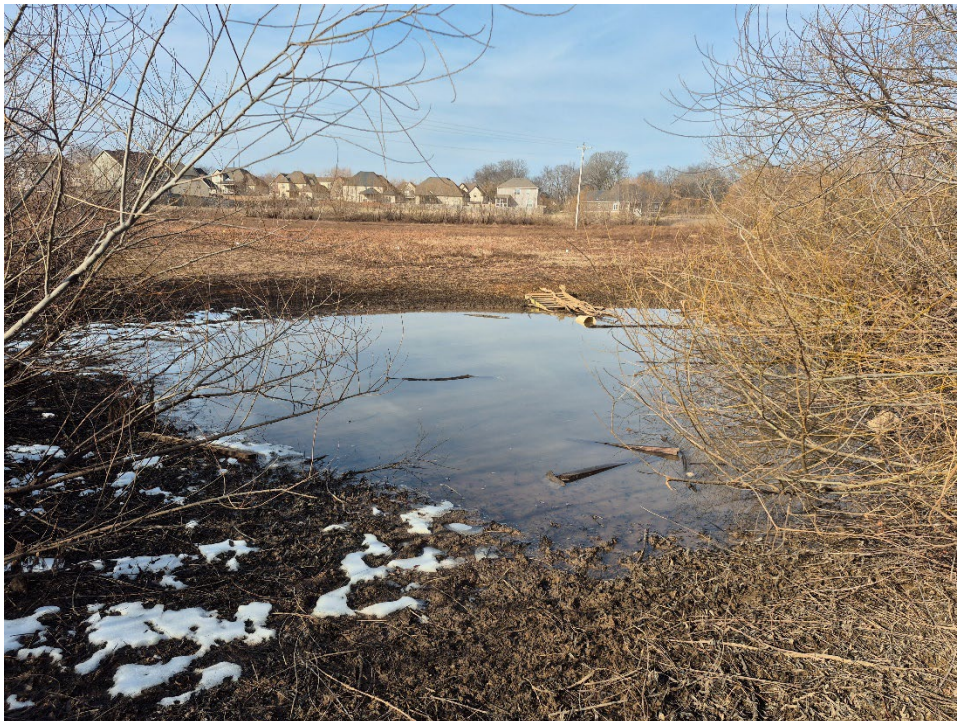
View looking at depression SH-02

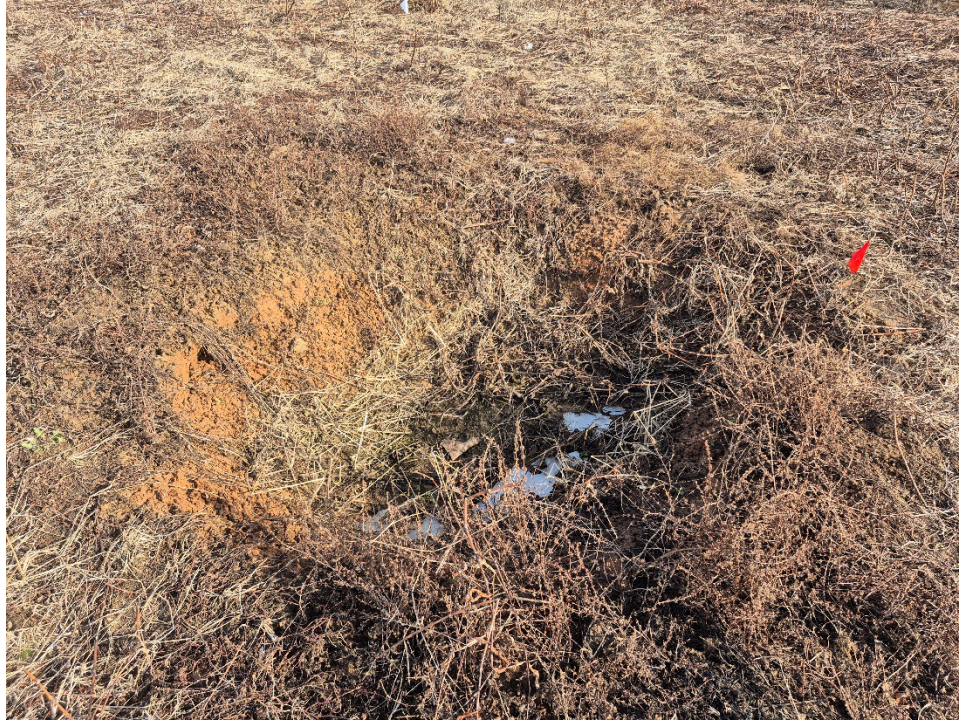
View looking at depression SH-03

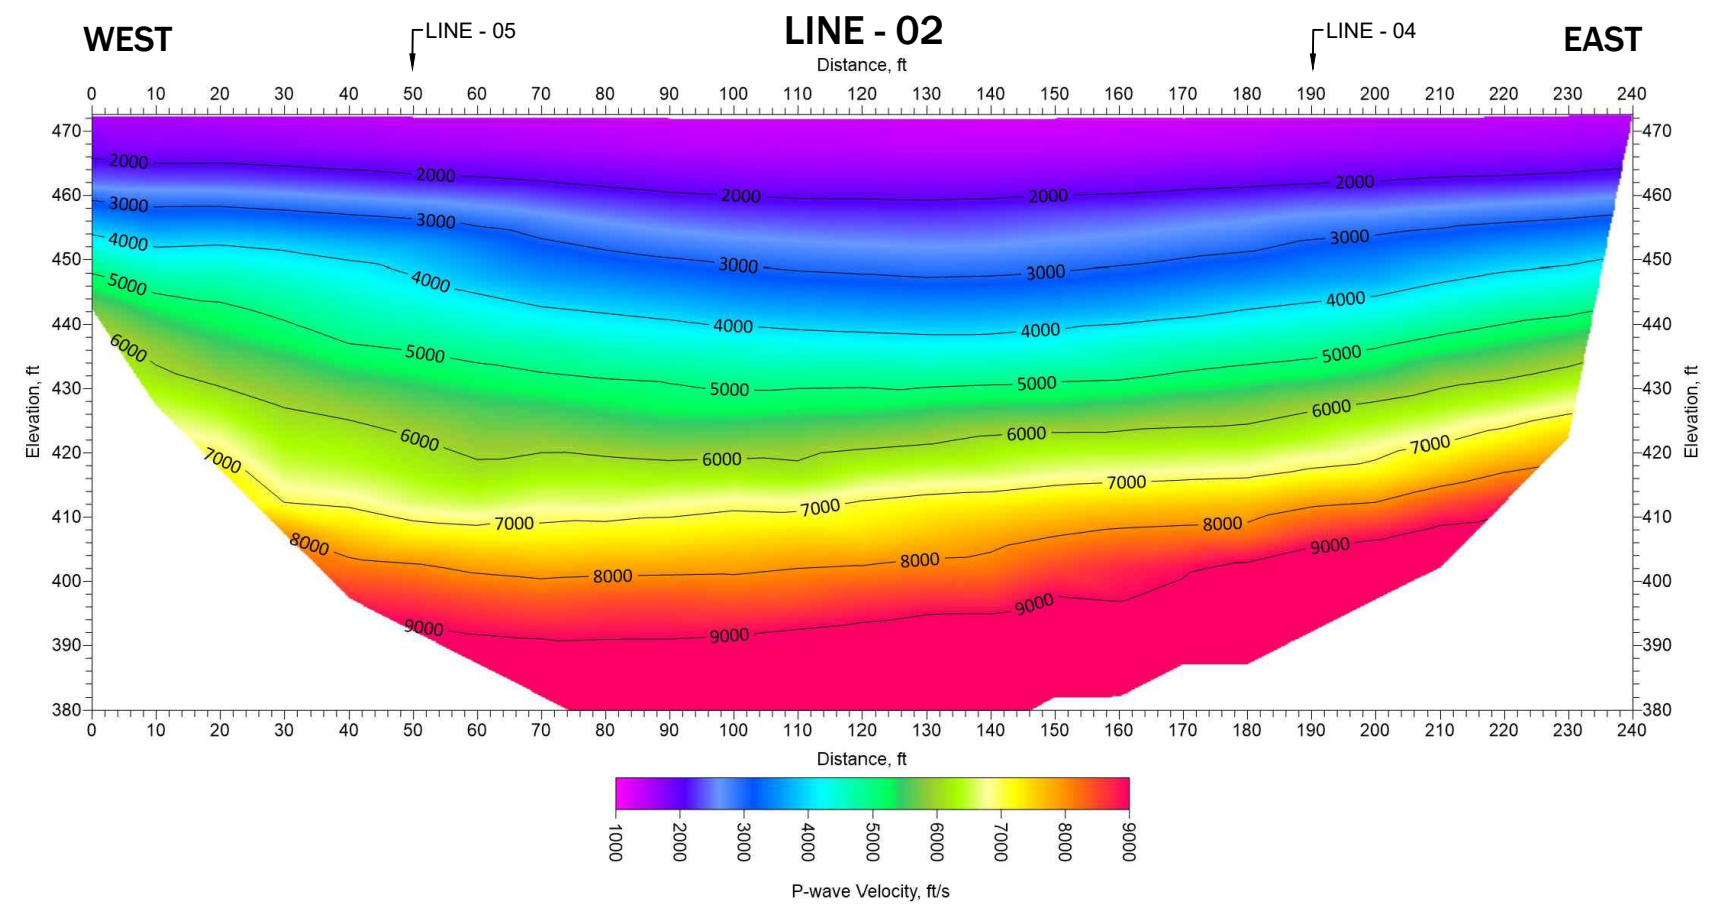
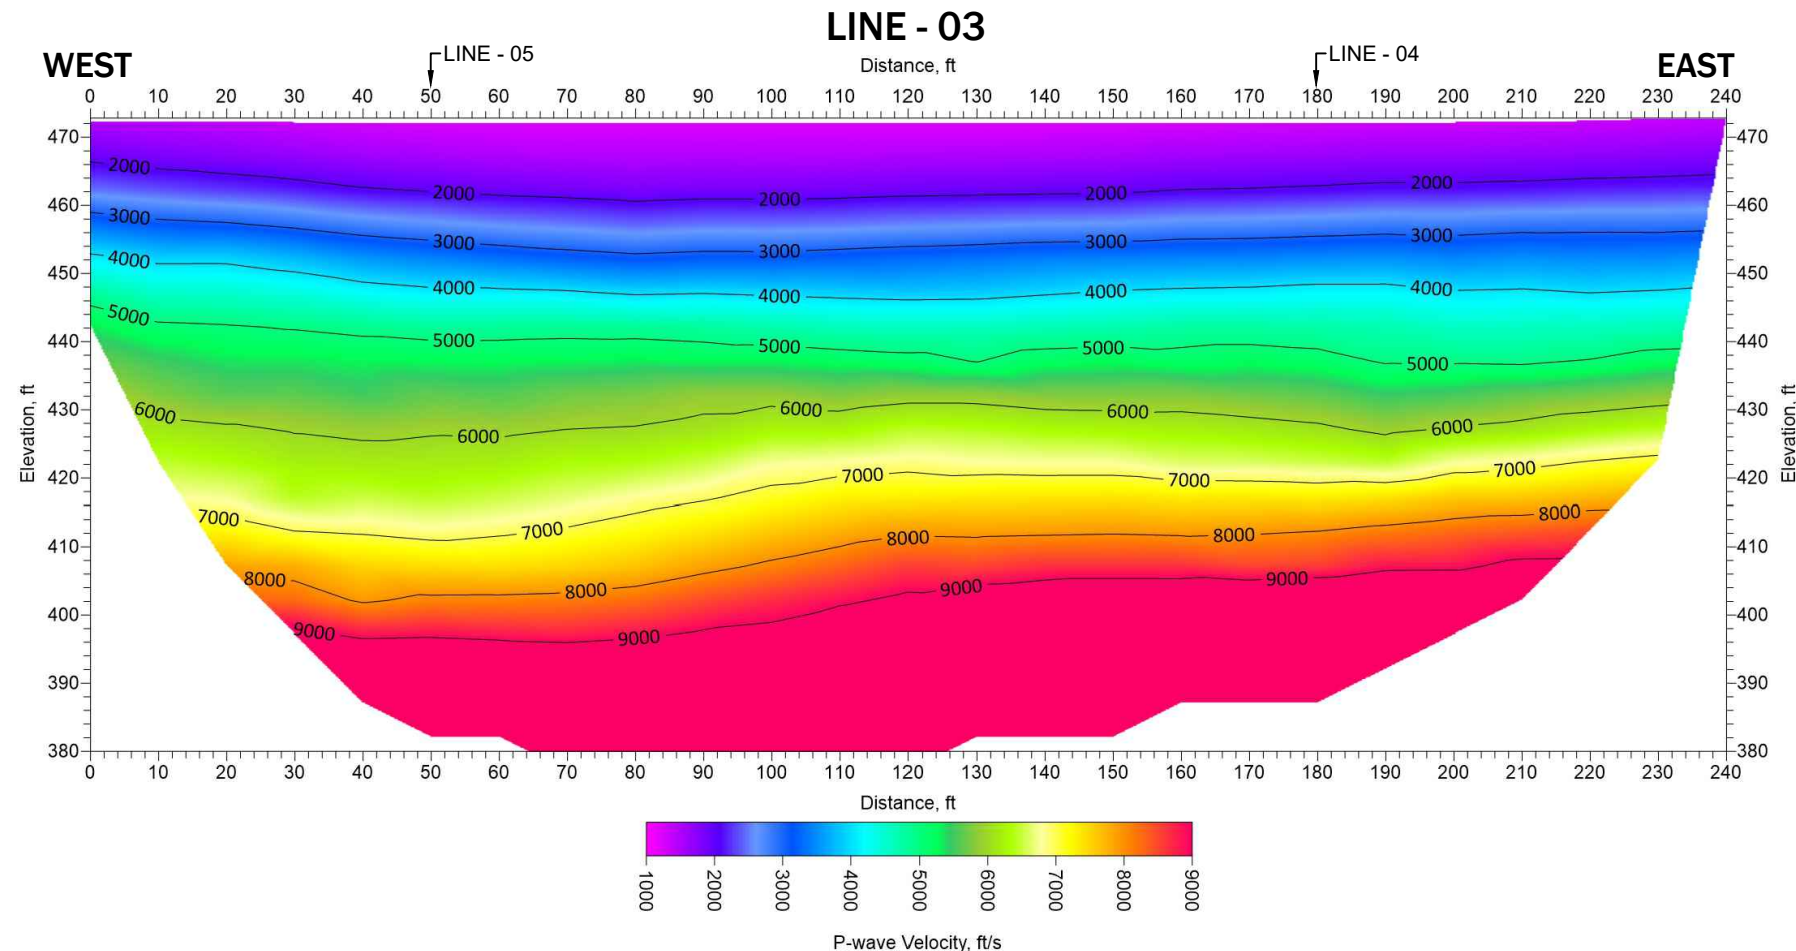
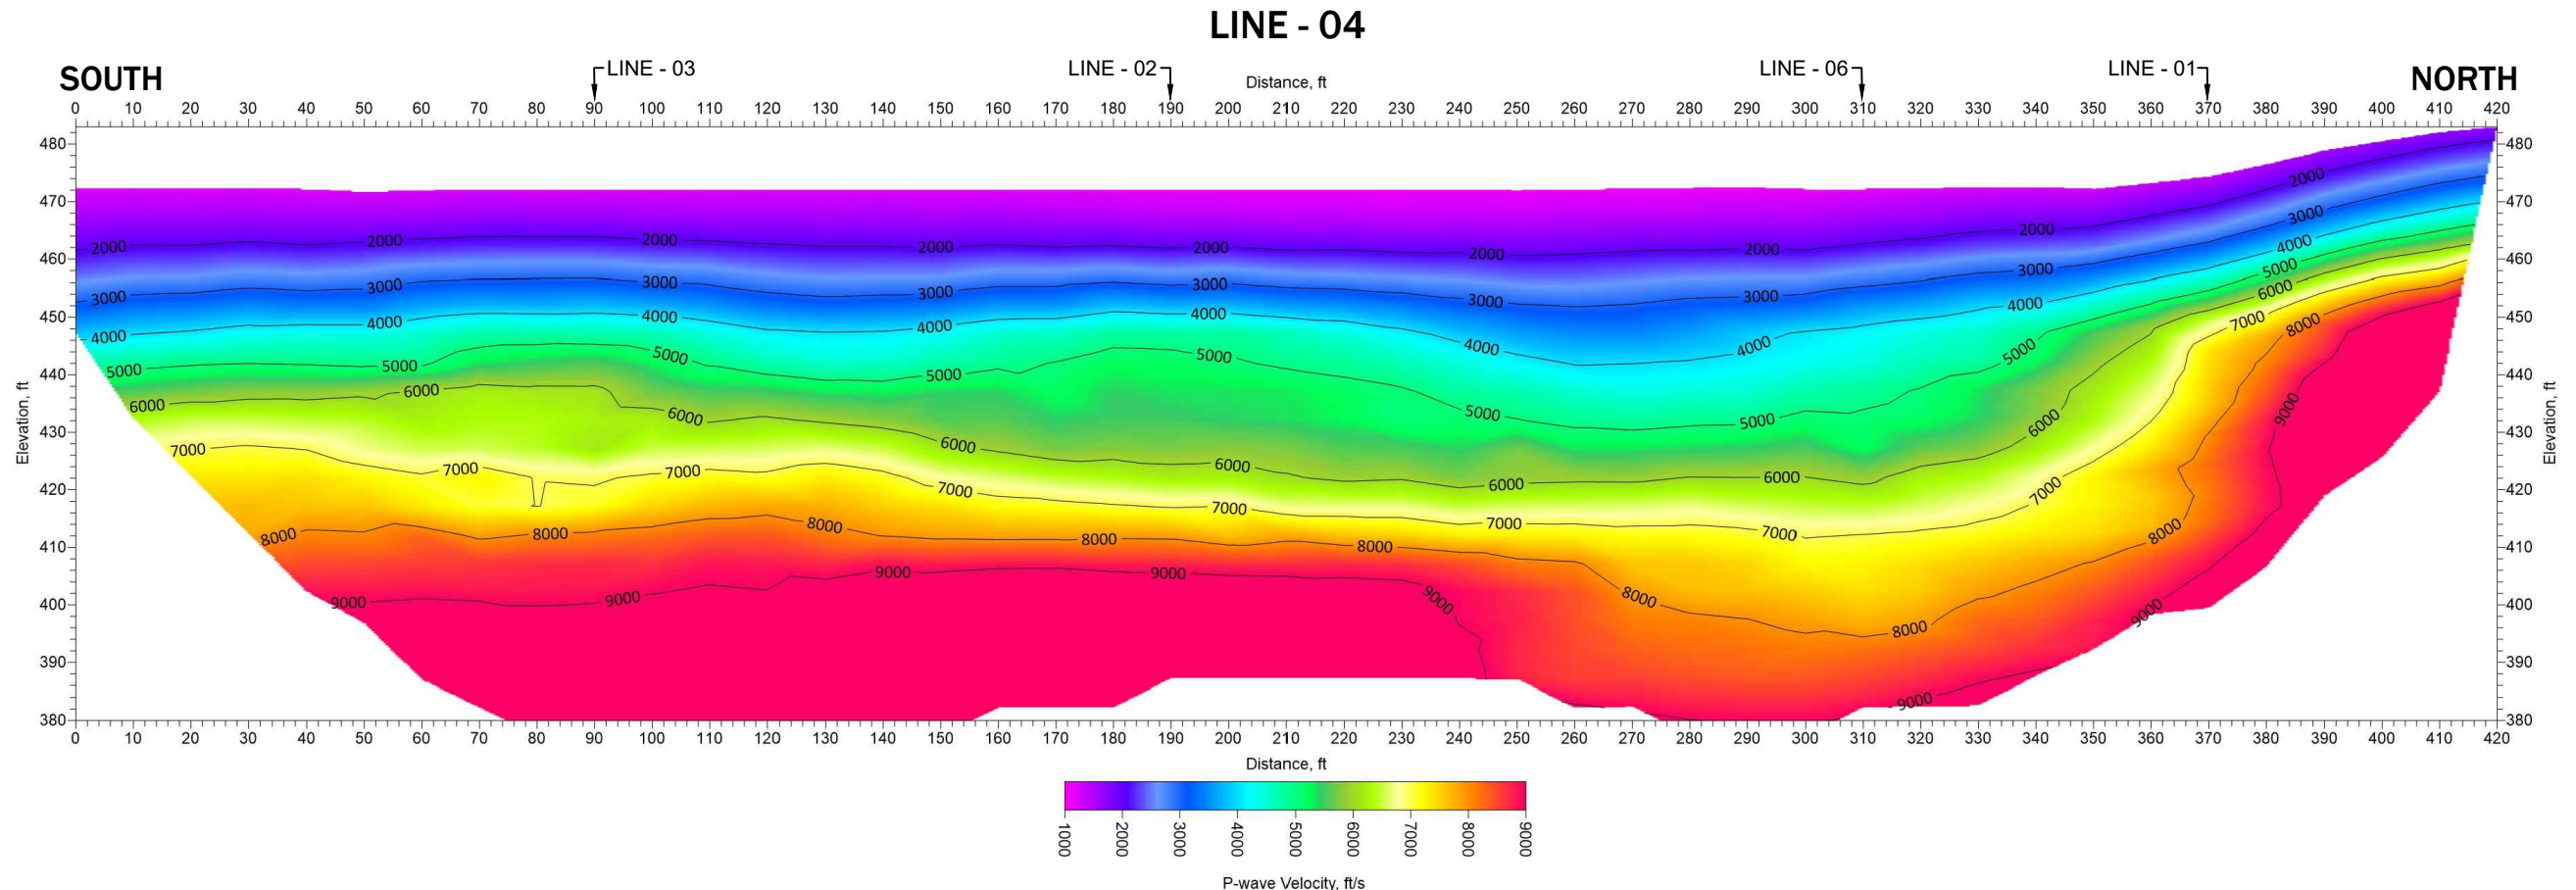
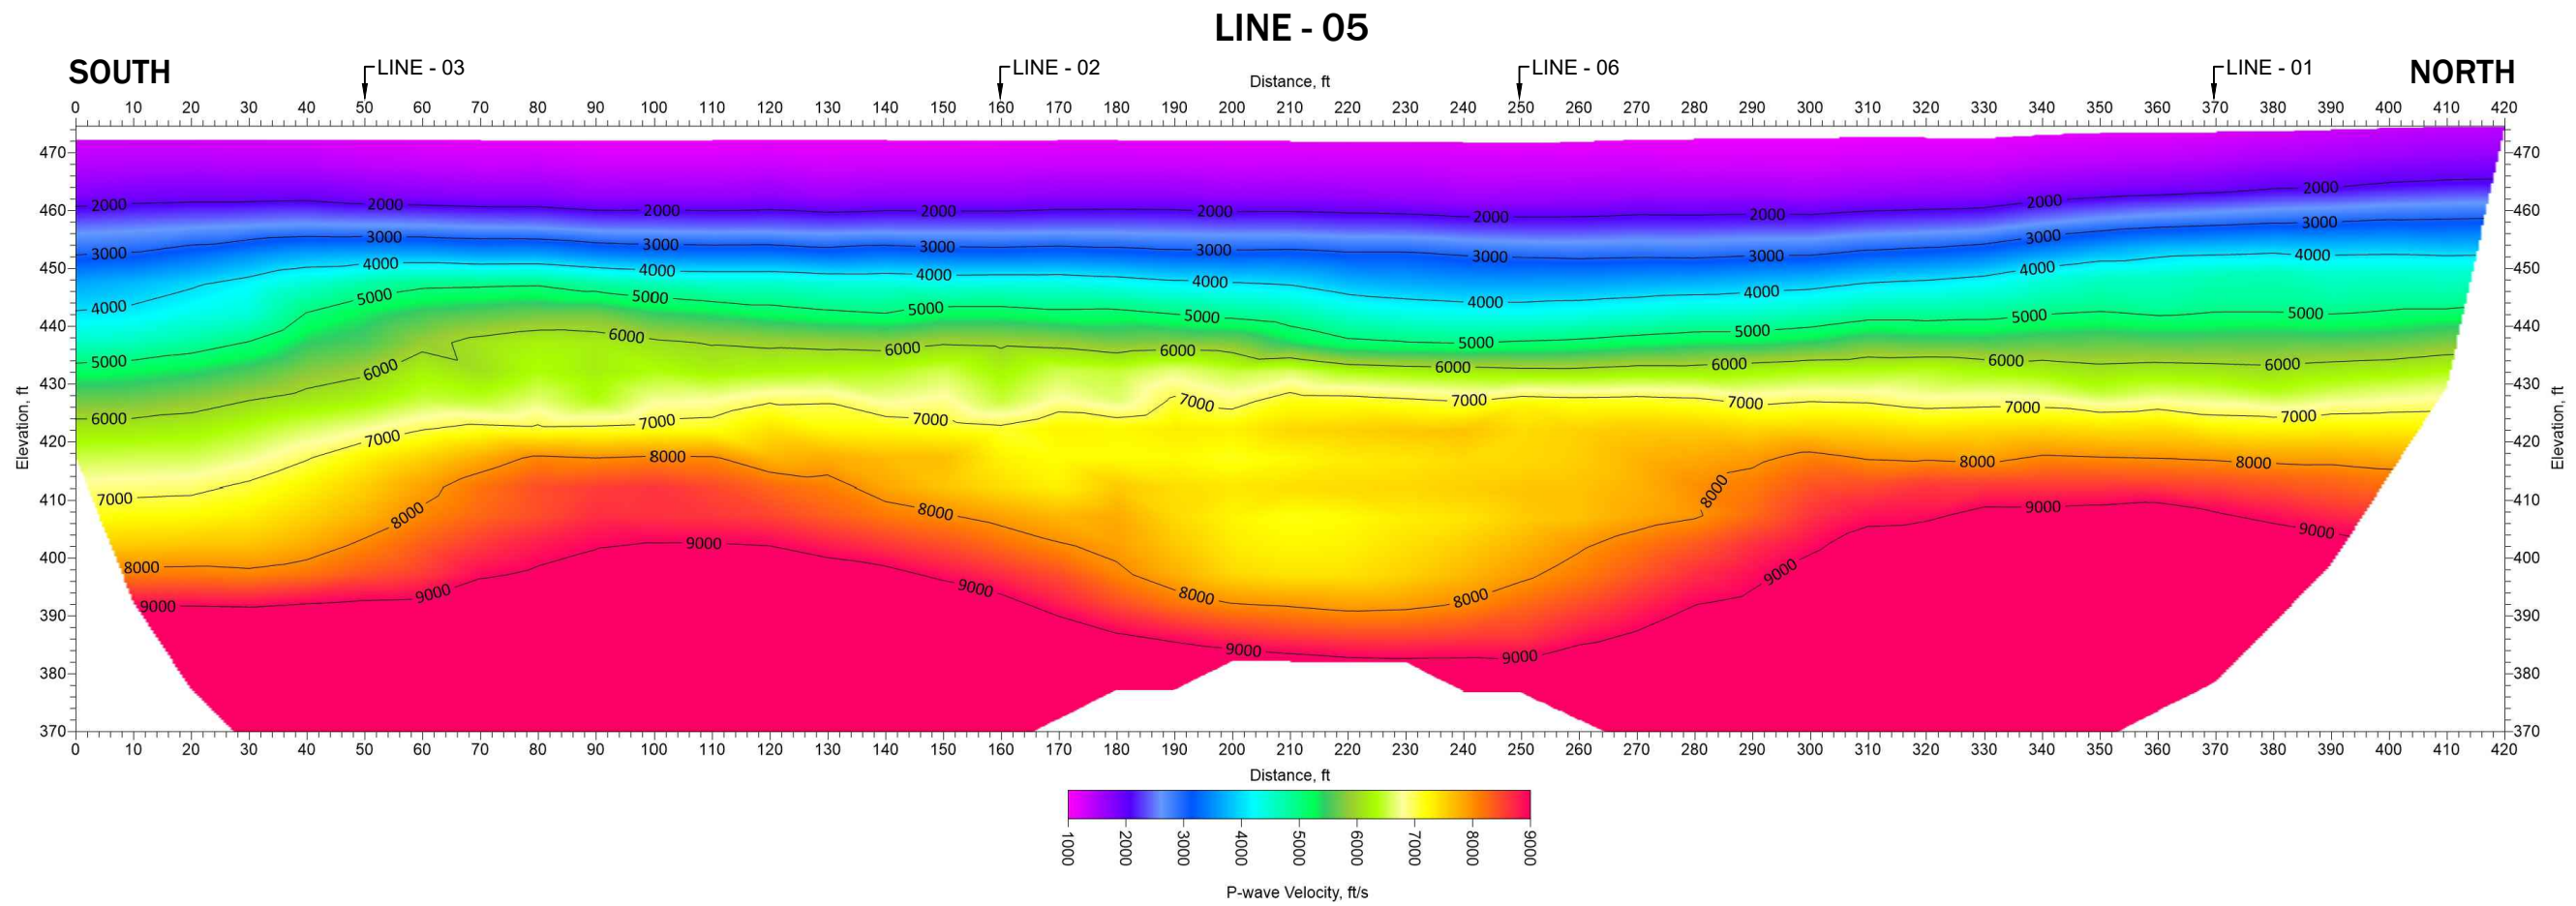
Seismic refraction testing produced subsurface profiles of variable seismic velocities below the arrays. The seismic velocities represented on the profiles, which are shown in the Appendix, are velocities of P-waves moving through the subsurface. The P-wave velocity of a material can be correlated with material type. In general, soil materials have slower P-wave velocities than harder, denser materials like bedrock. The transitional materials between soil and bedrock have intermediate P-wave velocities. The correlation between velocity and material type varies and is affected by many factors, including consistency (strength, stiffness, density of the material), unit weight, and presence or absence of groundwater. We interpreted the refraction profiles using the approximate correlation between P-wave velocity and generalized subsurface material type shown in the table below. This correlation is based on our experience, but actual depths of soil, weathered rock, and bedrock may vary because we did not have site-specific boring data with which to refine our interpretations.

Color Range	P-Wave Velocity Range (ft/s)	Inferred Subsurface Material
Violet to Green	1,000 to 5,000	Soil Overburden
Green	5,000 to 6,000	Transitional Soil/Weathered Bedrock Zone
Green to Red	> 6,000	Competent Bedrock

The velocity profile for each array line is included in the Appendix. We used a P-wave velocity of 5,000 fps to represent the approximate boundary between soil/weathered rock and competent bedrock on each of the array lines measured. Using this criterion, the refraction profiles show the depths of soil and weathered rock overburden above competent bedrock appear irregular and vary between about 15 feet and 40 feet below existing grades. The arrays were surveyed, and we interpolated the ground surface elevations along each array based on available 2-foot topographic contours across the site from publicly available Tennessee LiDAR and used the interpolated elevations to approximate the elevations of the inferred top of rock along each array line. Depending on location across the site, the top of rock elevations indicated by the refraction results ranged from about 430 feet to about 464 feet.

NOTE: VELOCITY 5000 FT/S REPRESENTS THE APPROXIMATE TOP OF BEDROCK.
